## **Test report BM 08/10-16**

Examination of the bio-deterioration of the sample material according to DIN EN ISO 846

Zwaluw Acryl Ducting Seal  
(colour grey)\*

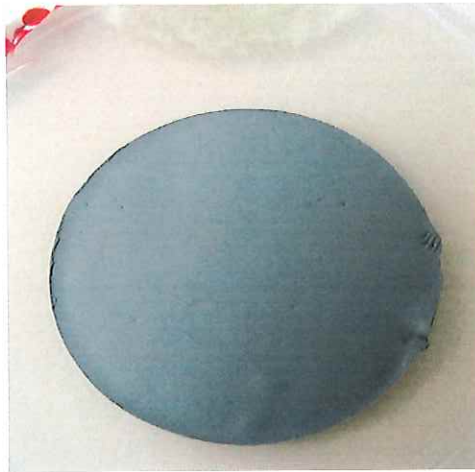
Photo 1: Material **Zwaluw Acryl Ducting Seal (colour grey)**:  
fungal growth was not visible to the naked eye

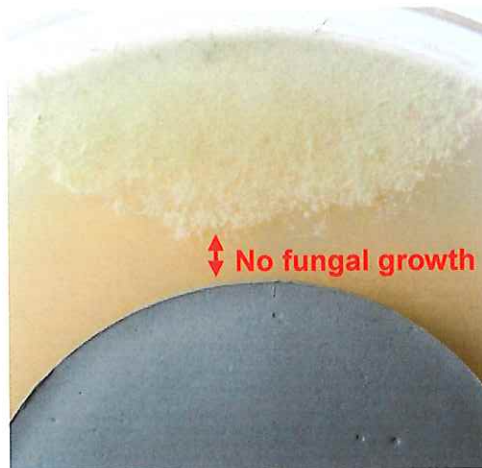
Photo 2: Material **Zwaluw Acryl Ducting Seal (colour grey)**:  
No growth of the test fungi could be detected directly around the material.

On the surface of material **Zwaluw Acryl Ducting Seal (colour grey)** fungal growth was not visible under the microscope. No growth of the test fungi could be detected directly around the material (see Photo 2).

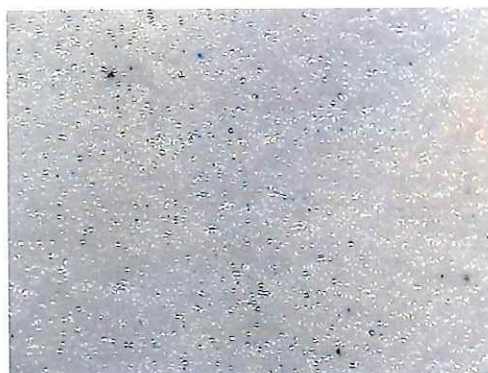
Photo 3: Material **Zwaluw Acryl Ducting Seal (colour grey)**  
(at a magnification of x 50): fungal growth was not visible under the microscope
