PROM with extended alarm functions

For Gateway type
AKA 243 / 244

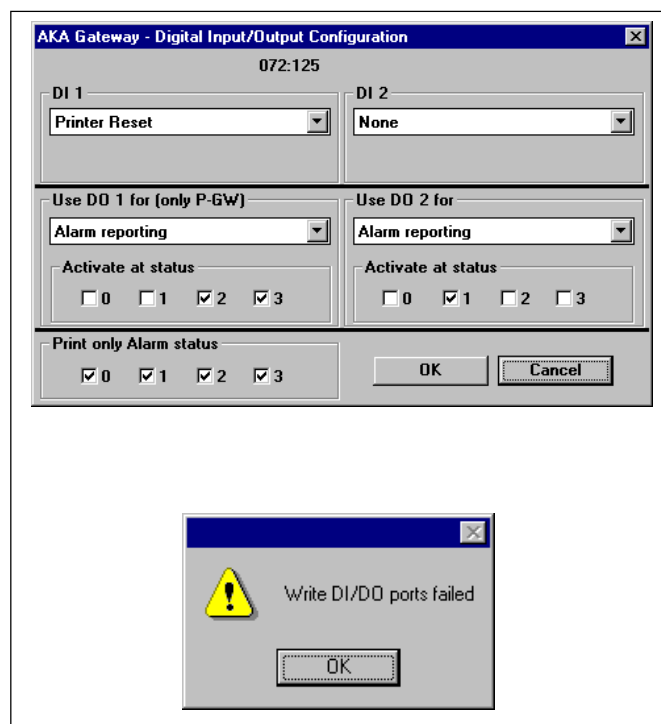
Configuration

The settings for the inputs and outputs are fixed and cannot be changed. For your information, the settings are as follows:

- "DI 2" is set to "NONE", but the function that zero-sets the relays is active.
- "DO 1" is set to "Alarm reporting", and "Status 2" and "Status 3" are marked with a X.
- "DO 2" is set to "Alarm reporting", and "Status 1" is marked with a X.
- The printer settings "DI 1" and "Print only Alarm Status" are also fixed, as shown.
